**Subject: Annual Inspection Report  
Guntersville Municipal Airport**

# ANNUAL INSPECTION REPORT

July 27, 2010

GUNTERSVILLE MUNICIPAL  
(JOE STARNES FIELD) AIRPORT  
GUNTERSVILLE, ALABAMA

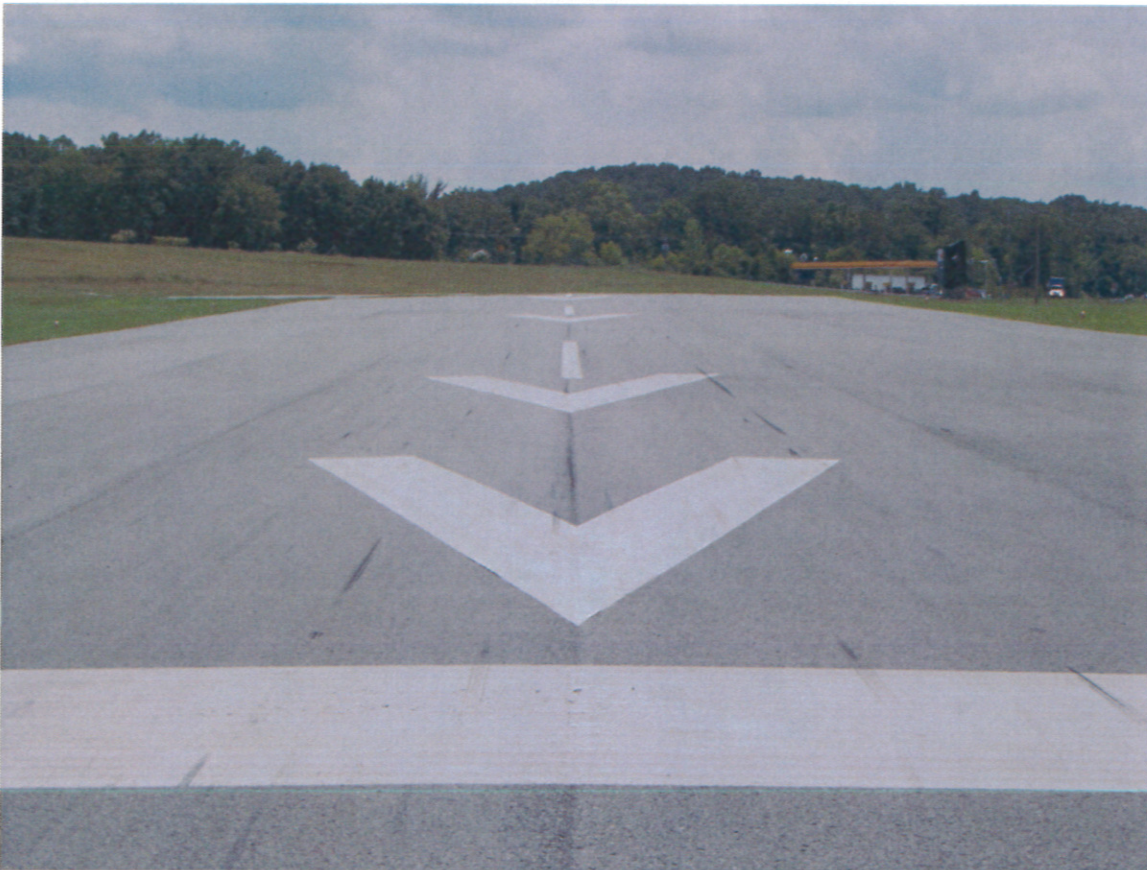
Photo 1

- ➔ Runway 3 – Due to the displaced threshold the approach is unobstructed and meets licensing requirements.

Approach to Runway 3 from the displaced threshold (802 feet from runway end.)

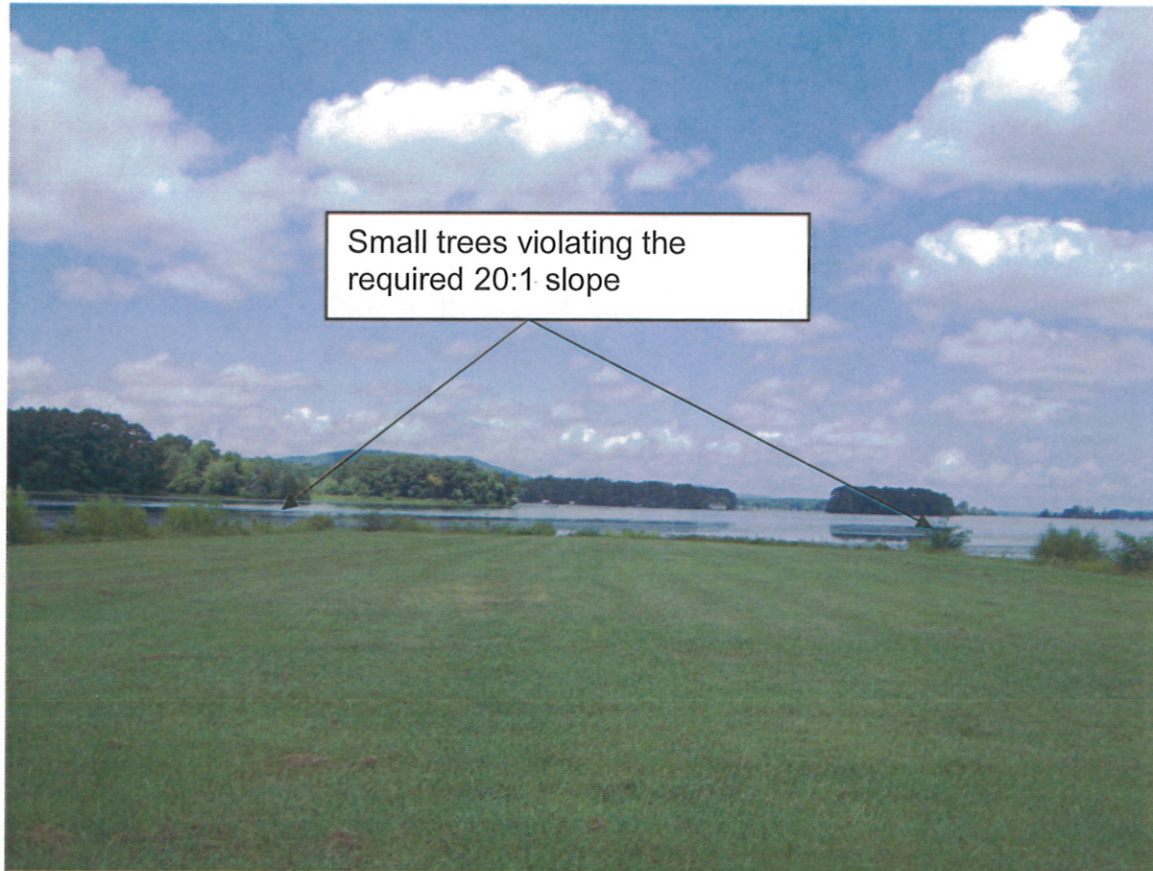
**Photo 2**

- Runway 21 – The approach to the runway is obstructed by small trees growing around the edge of the FAA Safety Area which is constructed into the lake.
- The FAA Runway Protection Zone is also violated by these same trees.

Approach to Runway 21

- In order to meet licensing requirements the obstructions located within the Approach/Departure Path for runway 21 must be cleared and maintained in that condition.
- To meet FAA Runway Protection Zone requirements the trees must be removed.

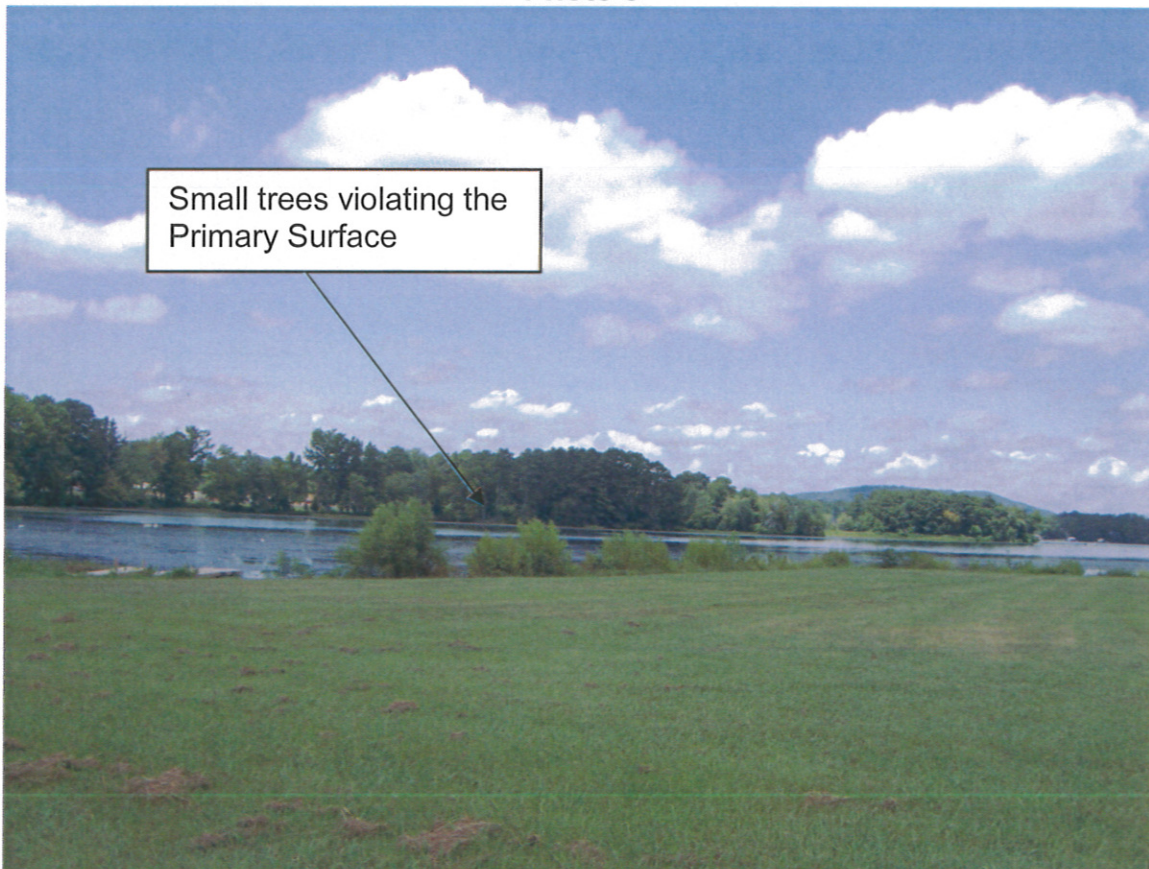
**Photo 3**

- The Primary Surface is obstructed by small trees growing around the FAA Safety Area adjacent to Runway 21.

Primary Surface adjacent to the Runway 21 threshold

- Remove all obstructions within 125 feet of runway centerline along both sides to a point 200 feet past the extended runway centerline from the runway ends to meet licensing requirements.
- These same small trees violate the FAA Object Free Area and must be removed.

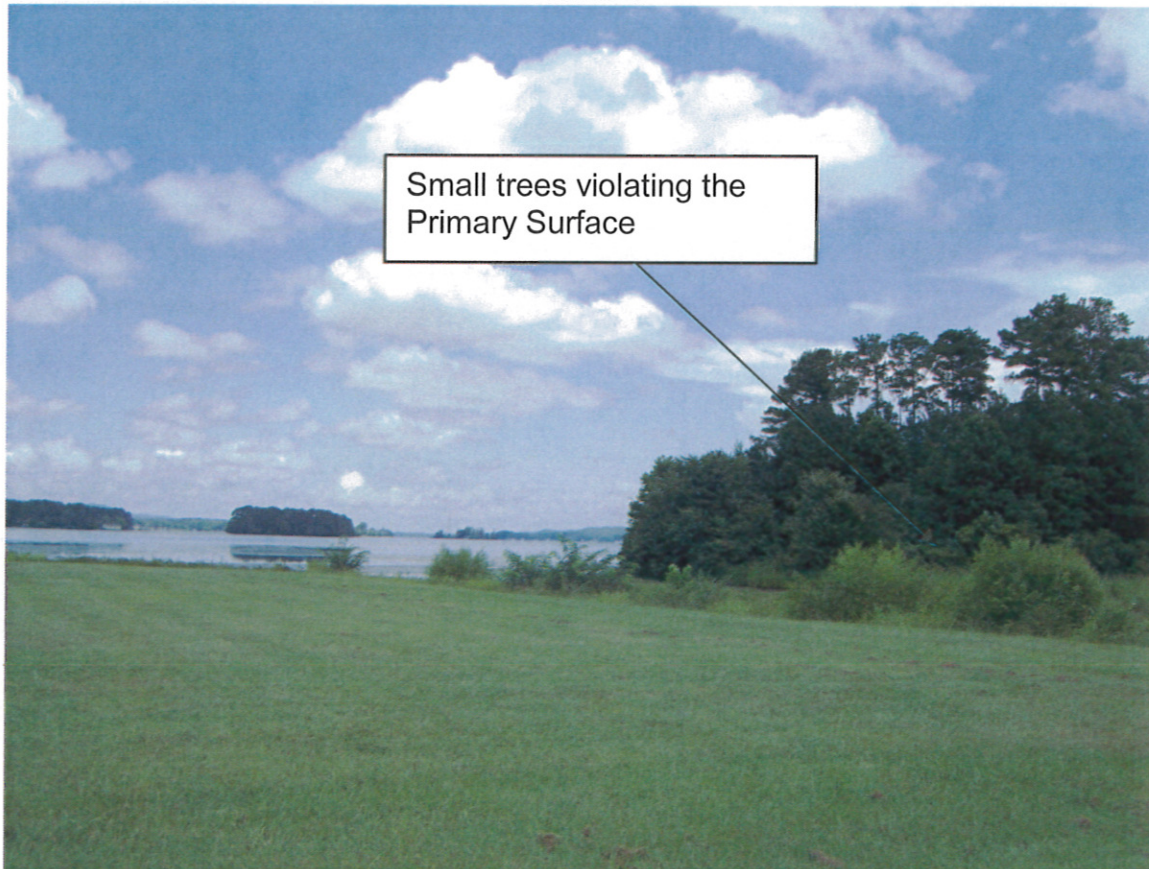
**Photo 4**

Primary Surface adjacent to the Runway 21 threshold

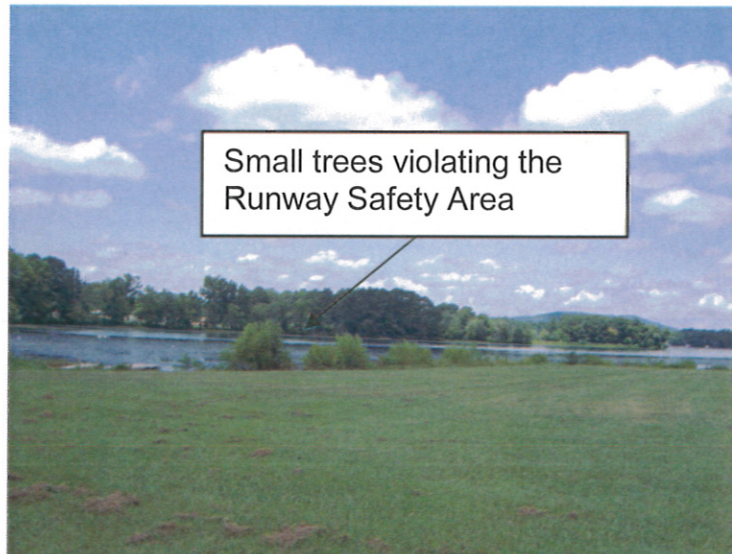
**Photo 3**

- The Runway Safety Area is violated by small trees adjacent to the Runway 21 threshold.

North West side of the FAA Safety Area of Runway 21

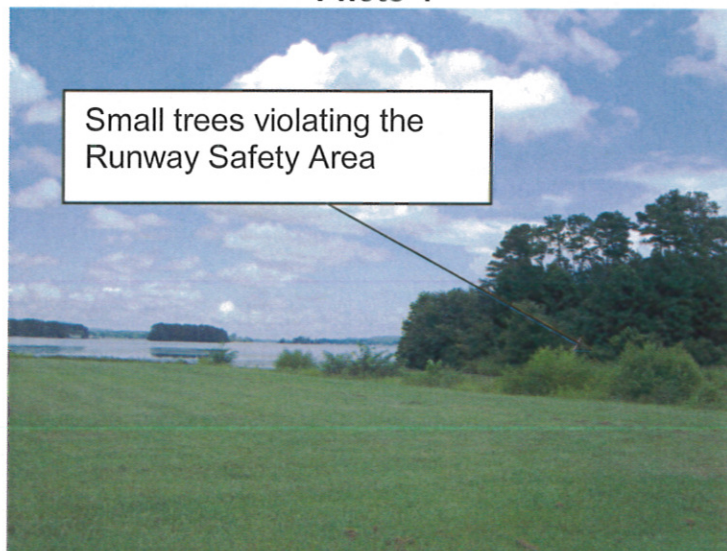
**Photo 4**

South East side of the FAA Safety Area of Runway 21

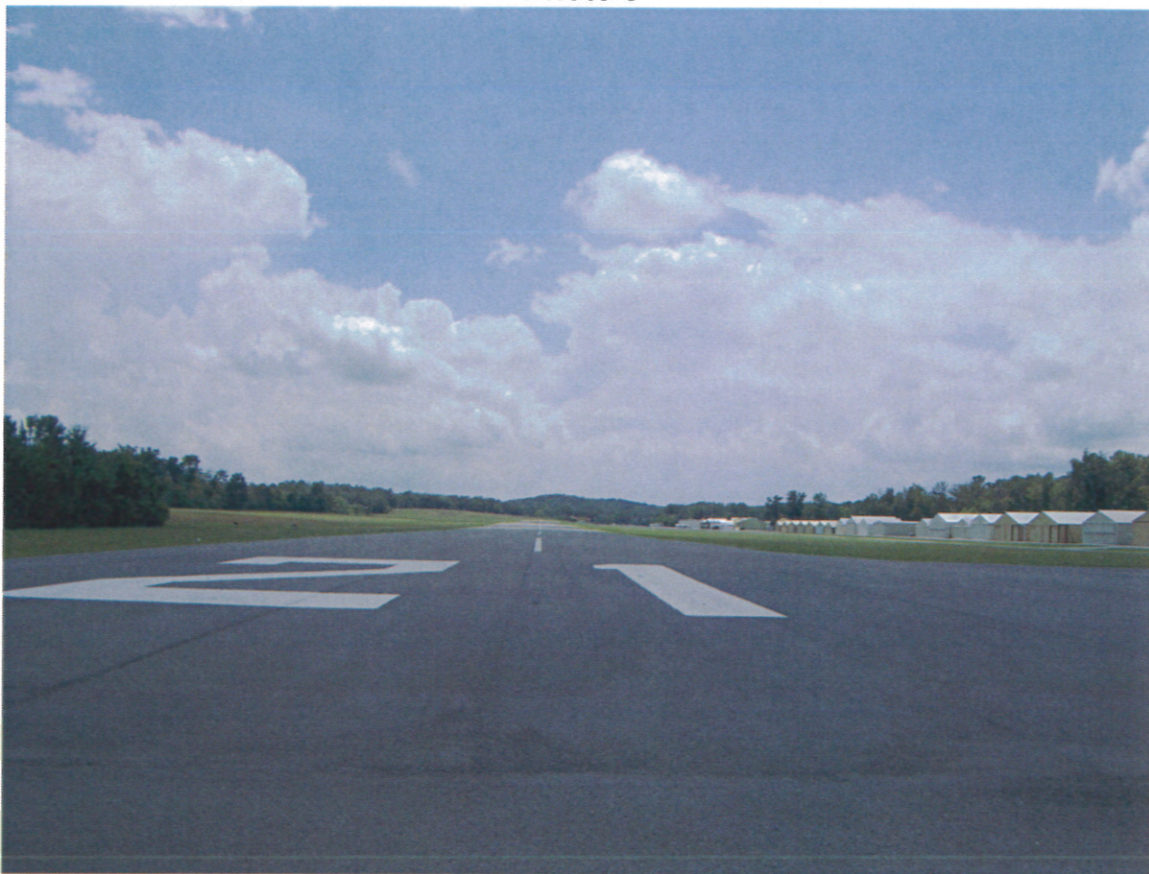
Photo 5

- ➔ The markings are in GOOD condition.

Runway Identifier markings of Runway 21

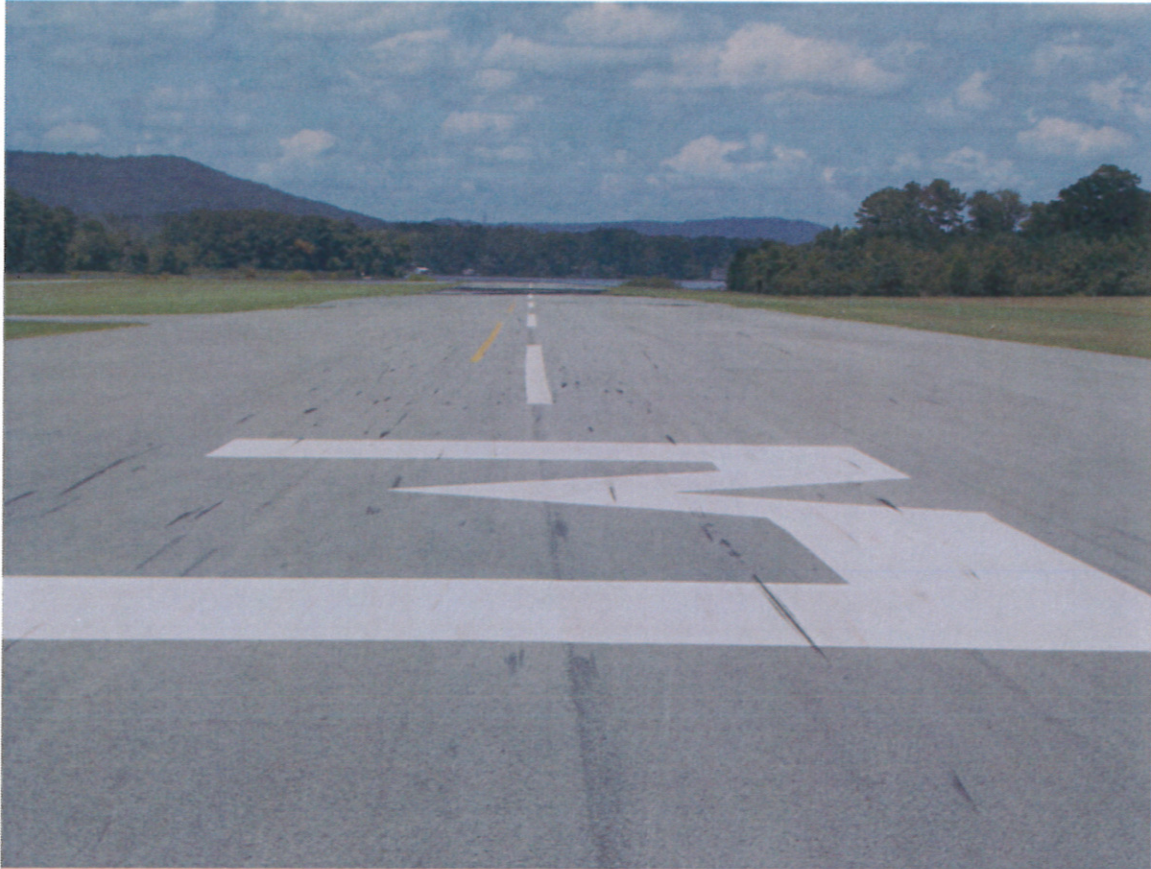
**Photo 6**

Runway Identifier markings of Runway 3

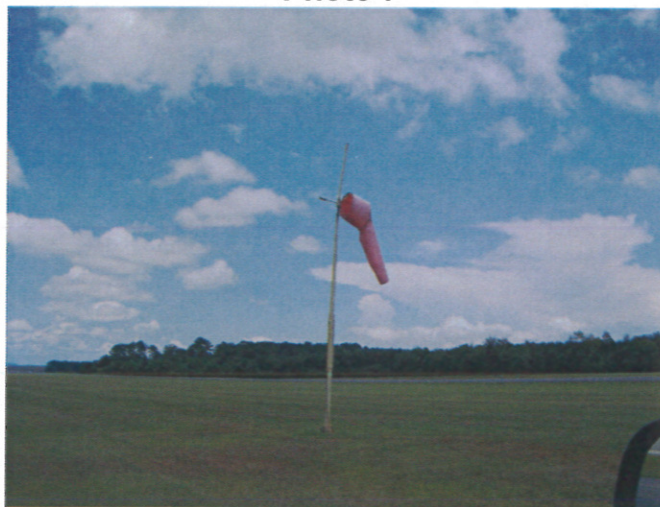
Photo 7

- ➔ There are two windsock assemblies located on the airport and neither is lighted.
- ➔ There must be a lighted wind indicator on the airport in order to meet the minimum licensing requirements for night operations.

Unlit windsock assembly near taxiway.

- ➔ NOTAM the airport closed to night operations until a lighted wind indicator has been placed on the airport.

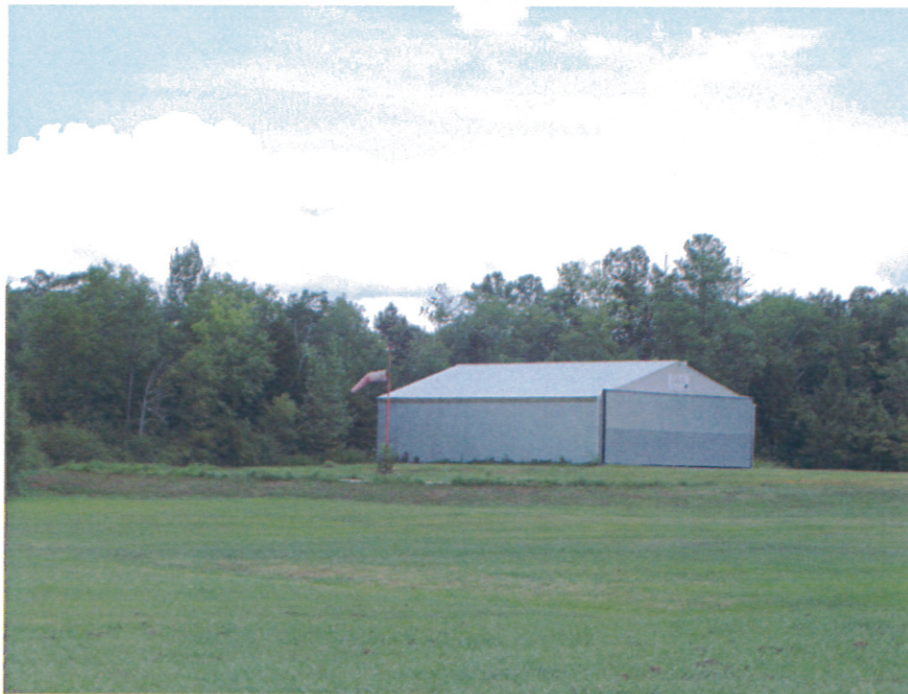
Photo 8

Lighted windsock assembly and segmented circle that has no electrical supply. This windsock was erected with Federal and State grant money and should have been maintained in working order.

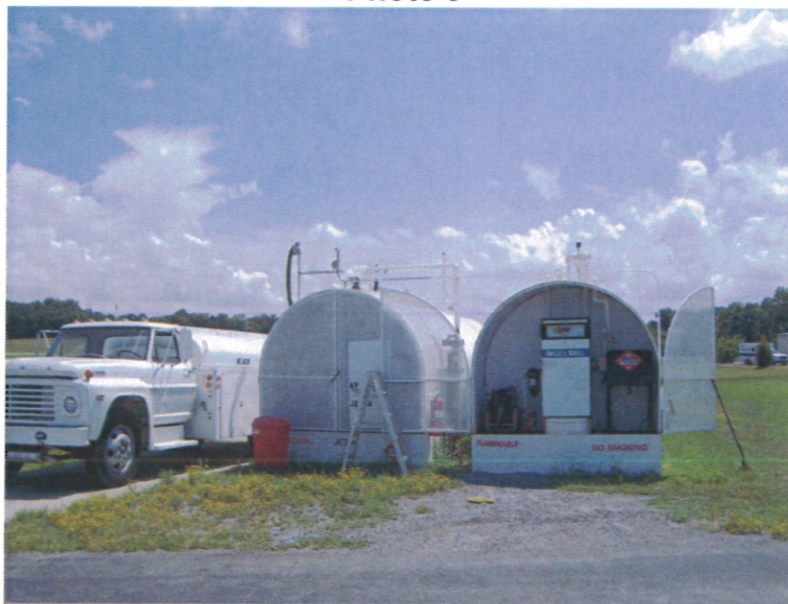
Photo 9

- ➔ The fueling area meets the requirements established by the Alabama Department of Transportation. However, the State of Alabama Department of Agriculture and Industries may have additional requirements for fueling systems that were not considered during this inspection.
- ➔ The fueling of 100LL is done from the fuel pumps. The Jet A is pumped from a fuel truck.

Fuel truck and pumps
